Name of Dam: South River No. 23

Inventory Number: VA 01508

PHASE I INSPECTION REPORT NATIONAL DAM SAFETY PROGRAM

SEPTEMBER 1979

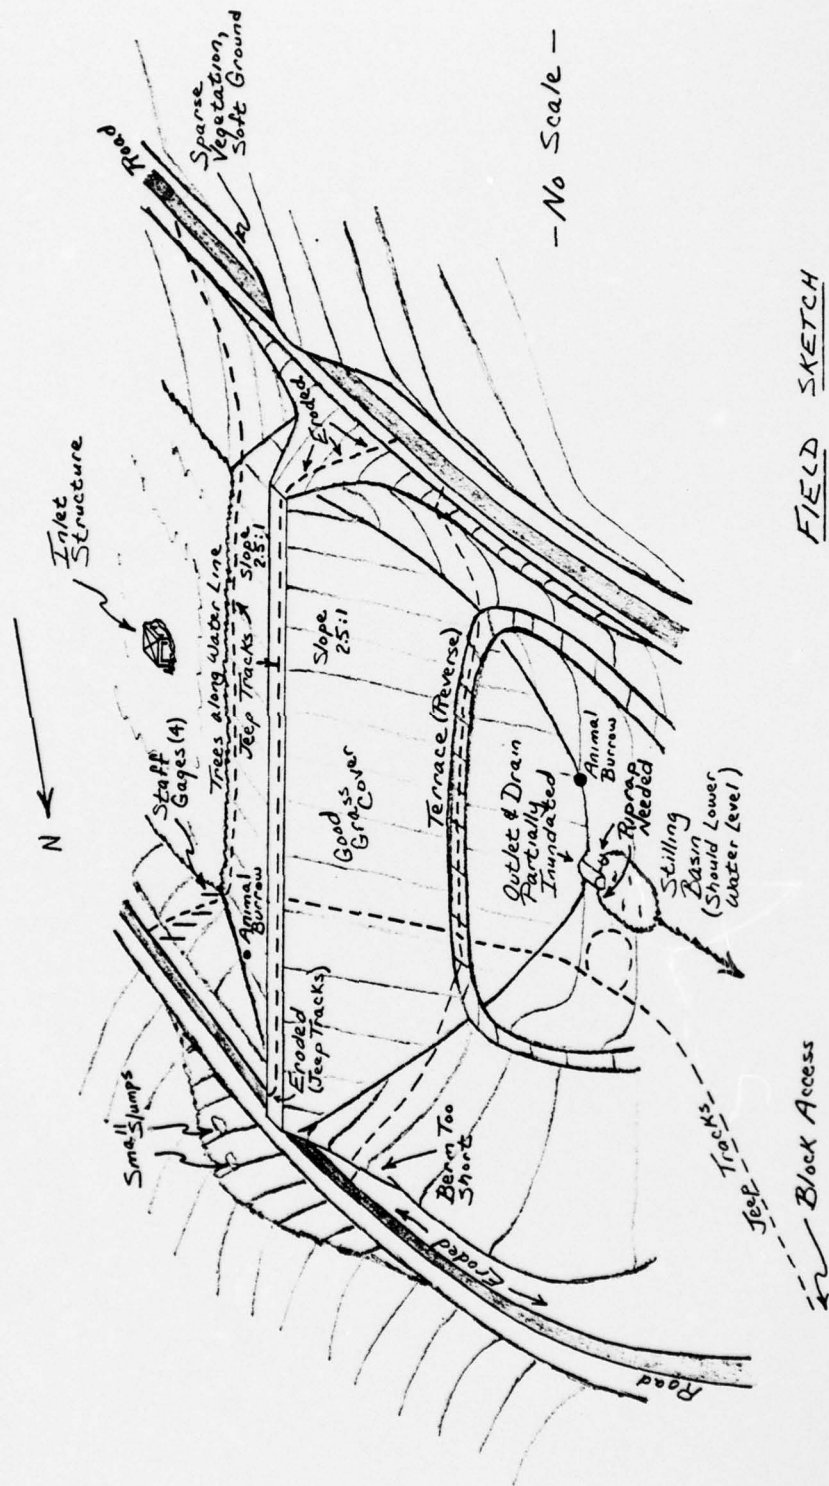
SOUTH RIVER #23, VIRGINIA
PLATE 1

Plate 1 is a Field Sketch of the facility which depicts the conditions observed during the visual inspection. The complete visual inspection check list is included in Appendix III. Following are summaries of the deficiencies noted during the inspection.

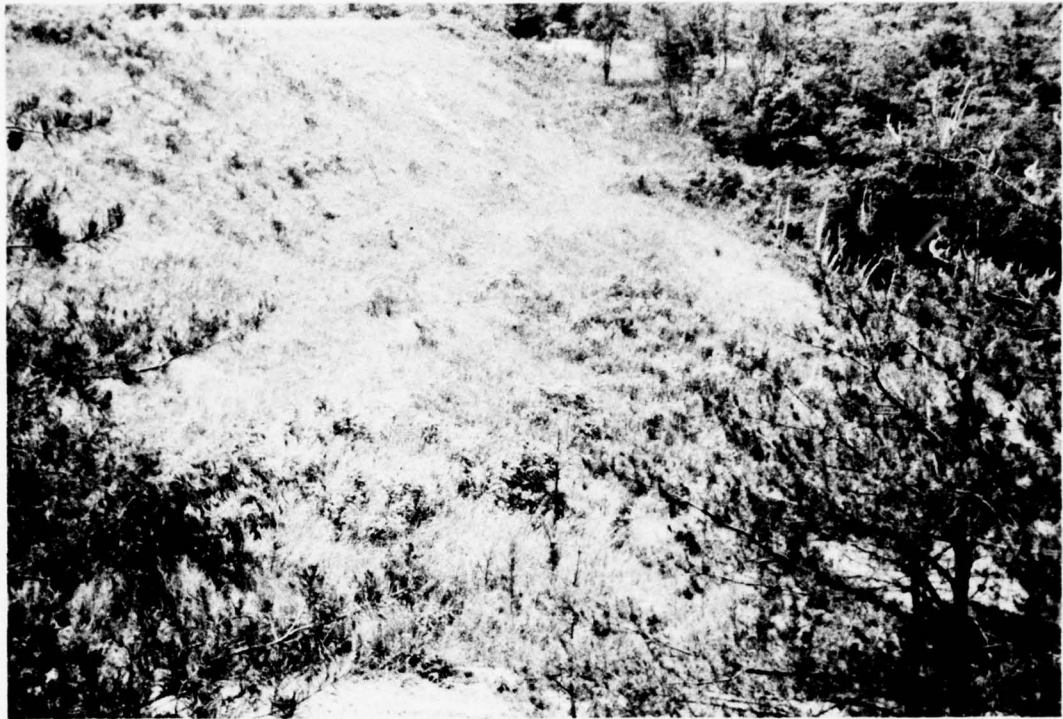
PHOTO 1. View of Downstream Embankment from Right Side of Dam

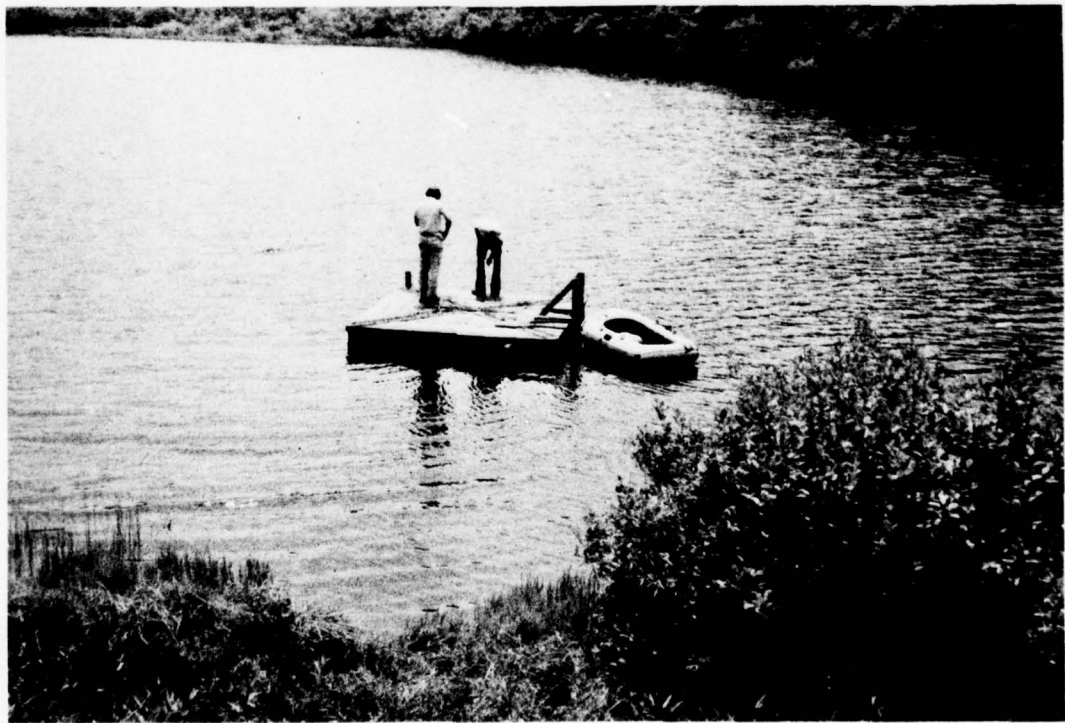
PHOTO 2. Riser Structure Looking Upstream

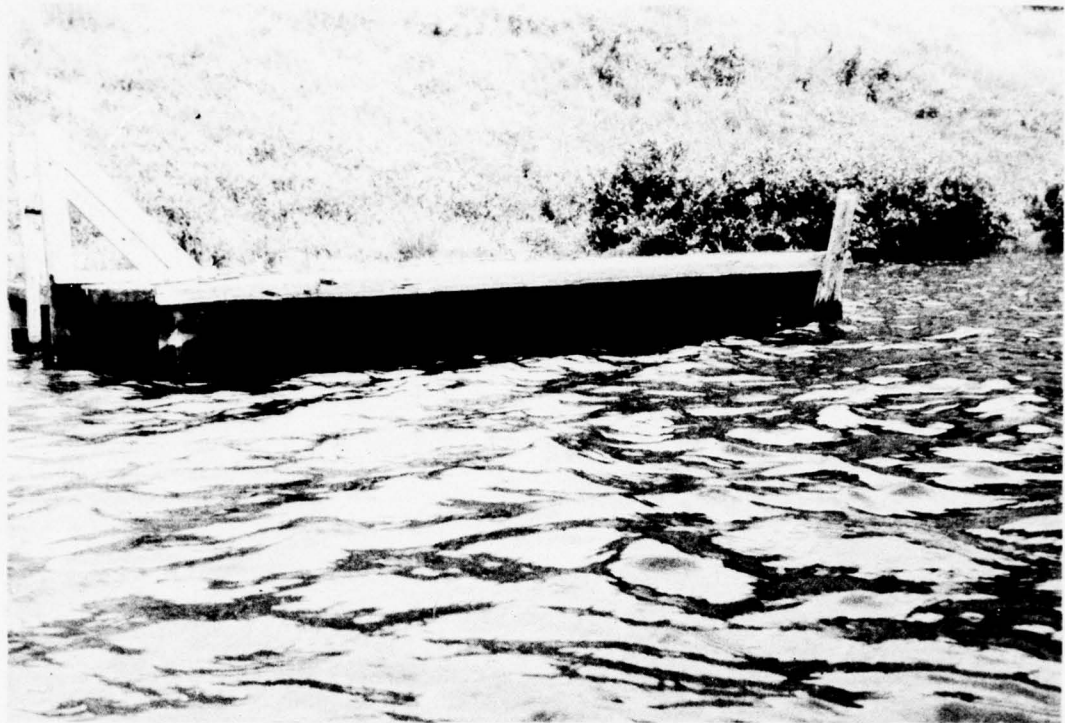
PHOTO 3. Close-up of Riser Looking Downstream

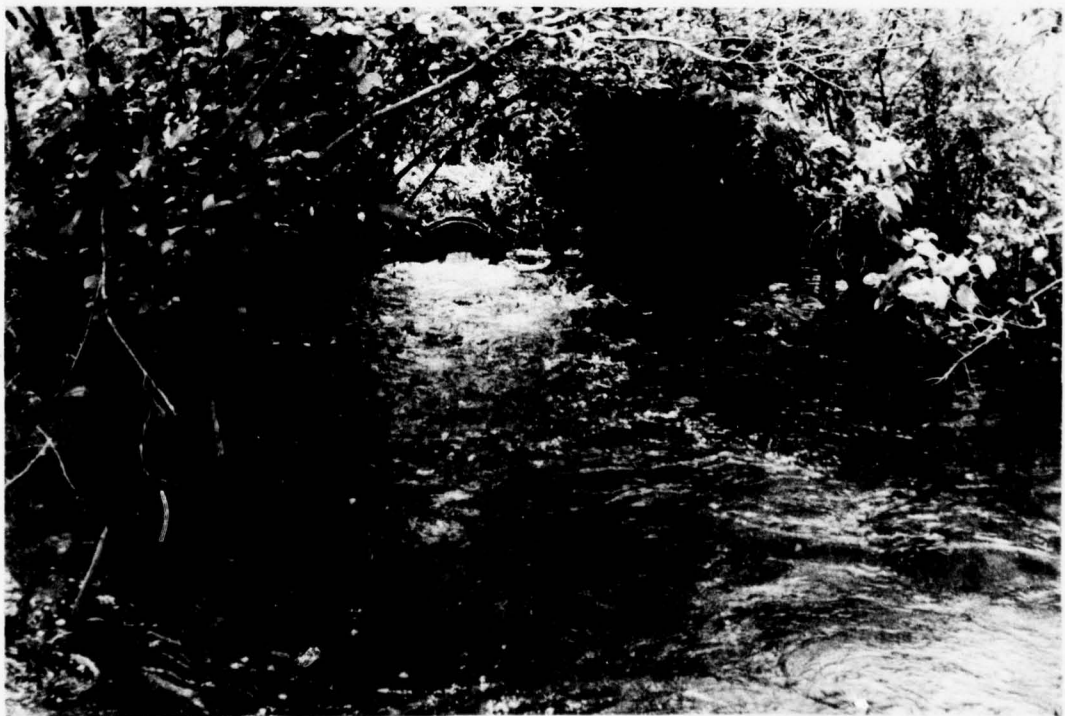
3). A 24 inch diameter reinforced concrete pipe discharges into a plunge pool approximately 300 feet from the riser at the downstream toe of the embankment (see Photo 4). The crest elevation of the drop-inlet is 1470.0 feet M.S.L. A manually operated sluice gate located on the upstream side of the riser can be used to drain the reservoir. A wooden trash rack is constructed on top of the riser to prevent blockage of the spillway with debris.

PHOTO 4. Principal Spillway Outlet, Overgrowth, and Stilling Basin

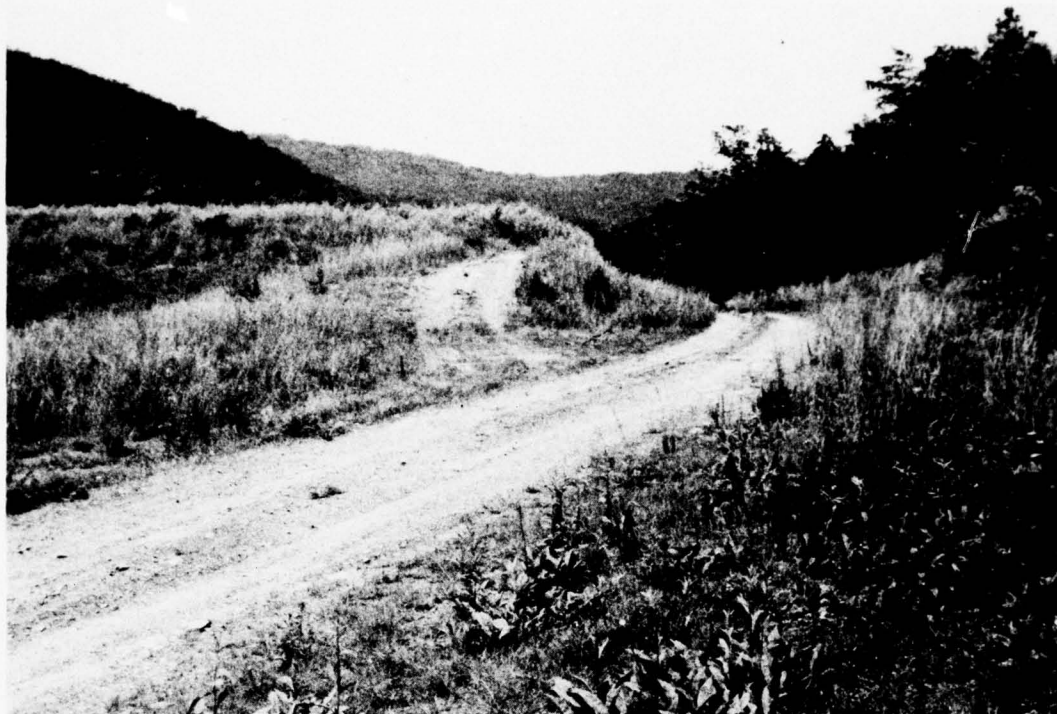
The upstream side of the hillside cut in the left emergency spillway is sparsely vegetated and soft.

PHOTO 5. Upstream View of Left Emergency Spillway

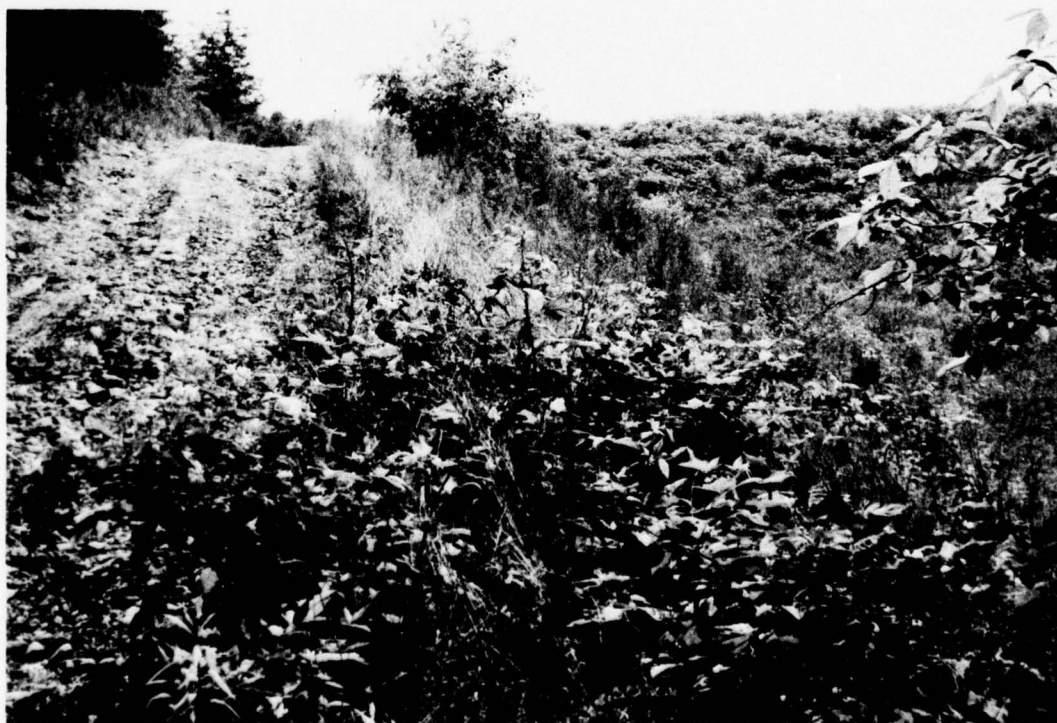
PHOTO 6. Discharge Channel of Right Emergency Spillway Looking Upstream

The road erosion should be repaired. The berm should be built up and lengthened to prevent flood waters from washing down the abutment slope prematurely onto the junction of the abutment and the embankment.

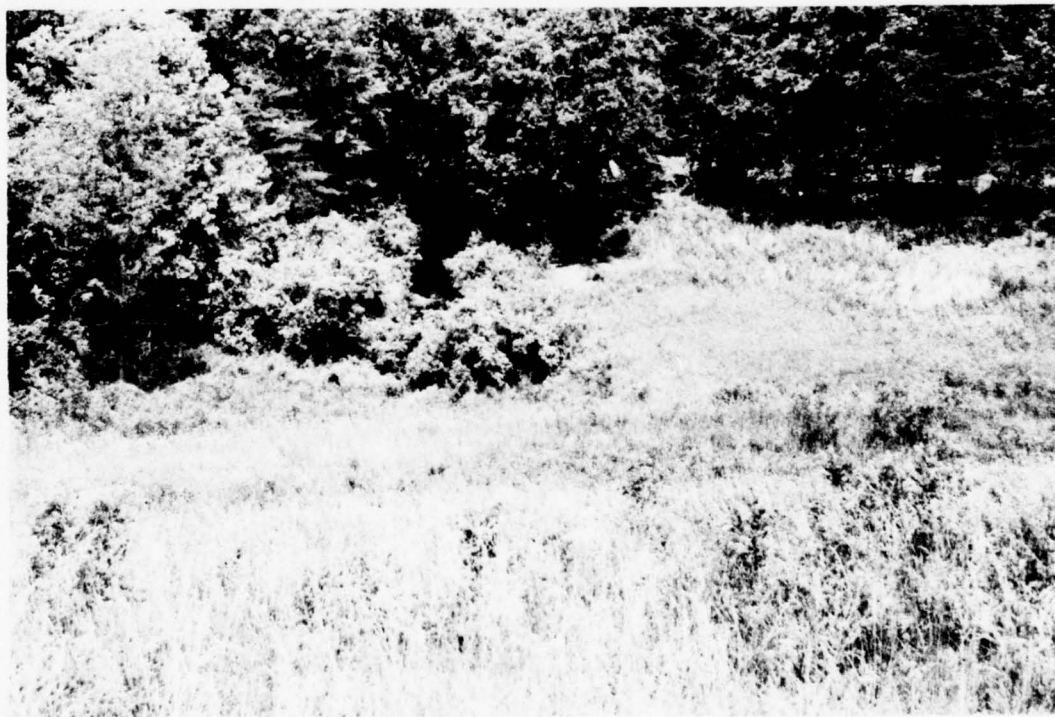
PHOTO 8. Downstream Channel from Crest of Dam
